2018 STRIPS Landowner Report

STRIPS 2018 Research Summary

2018 Research summary

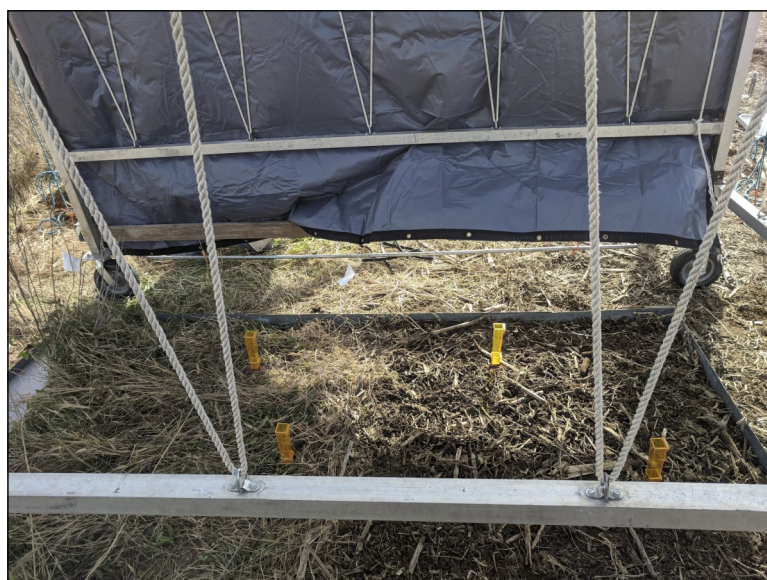
A view of the sampling set up under a rainfall simulation.

During plot runoff, six runoff water samples were taken at 5-minute intervals for microbial processing. Samples were also collected for 1-minute intervals to calculate runoff rate. Samples from the tank containing rainwater and samples of the manure were also taken to measure any organisms that were already present. DNA extraction was carried out on all samples and will be utilized for sequencing and molecular detection of DNA, which will help us identify which organisms are present. Water samples were combined from each of the nine plots and then tested for fecal indicator bacteria, tetracycline, and tylosin-resistant bacteria

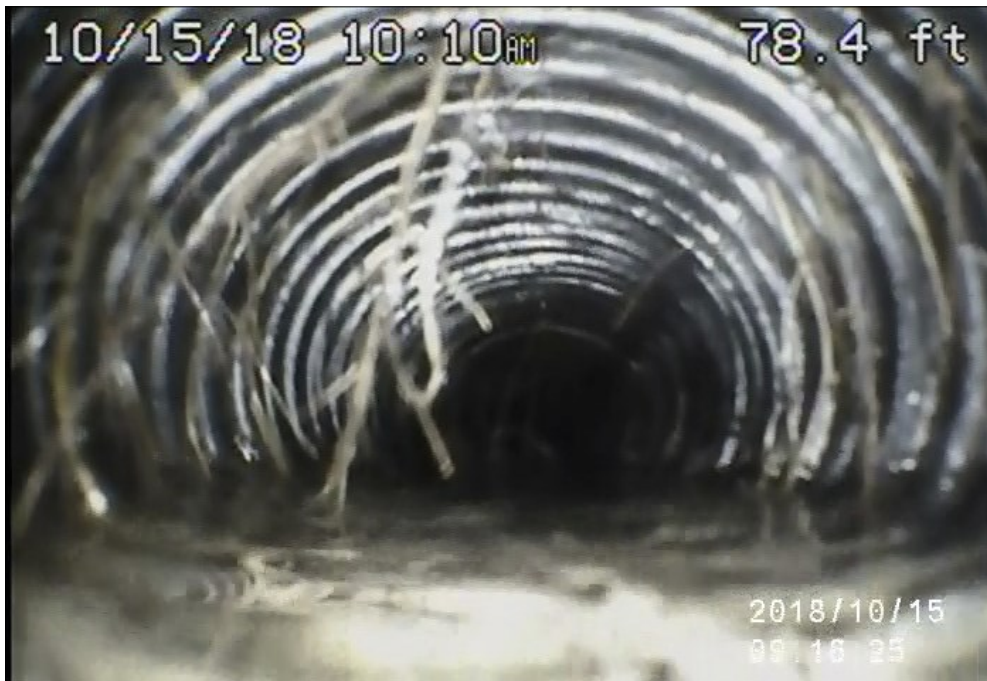
A screenshot of a tile investigation.

The TPC has shared the video with the ISU STRIPS team and other collaborators. Roots were prevalent along the entire 200' of videoed tile. While the roots were more dense in some areas than others, the density under the corn and prairie was similar. Though root biomass was present, the tile was functioning properly; about 1" of water was draining freely.

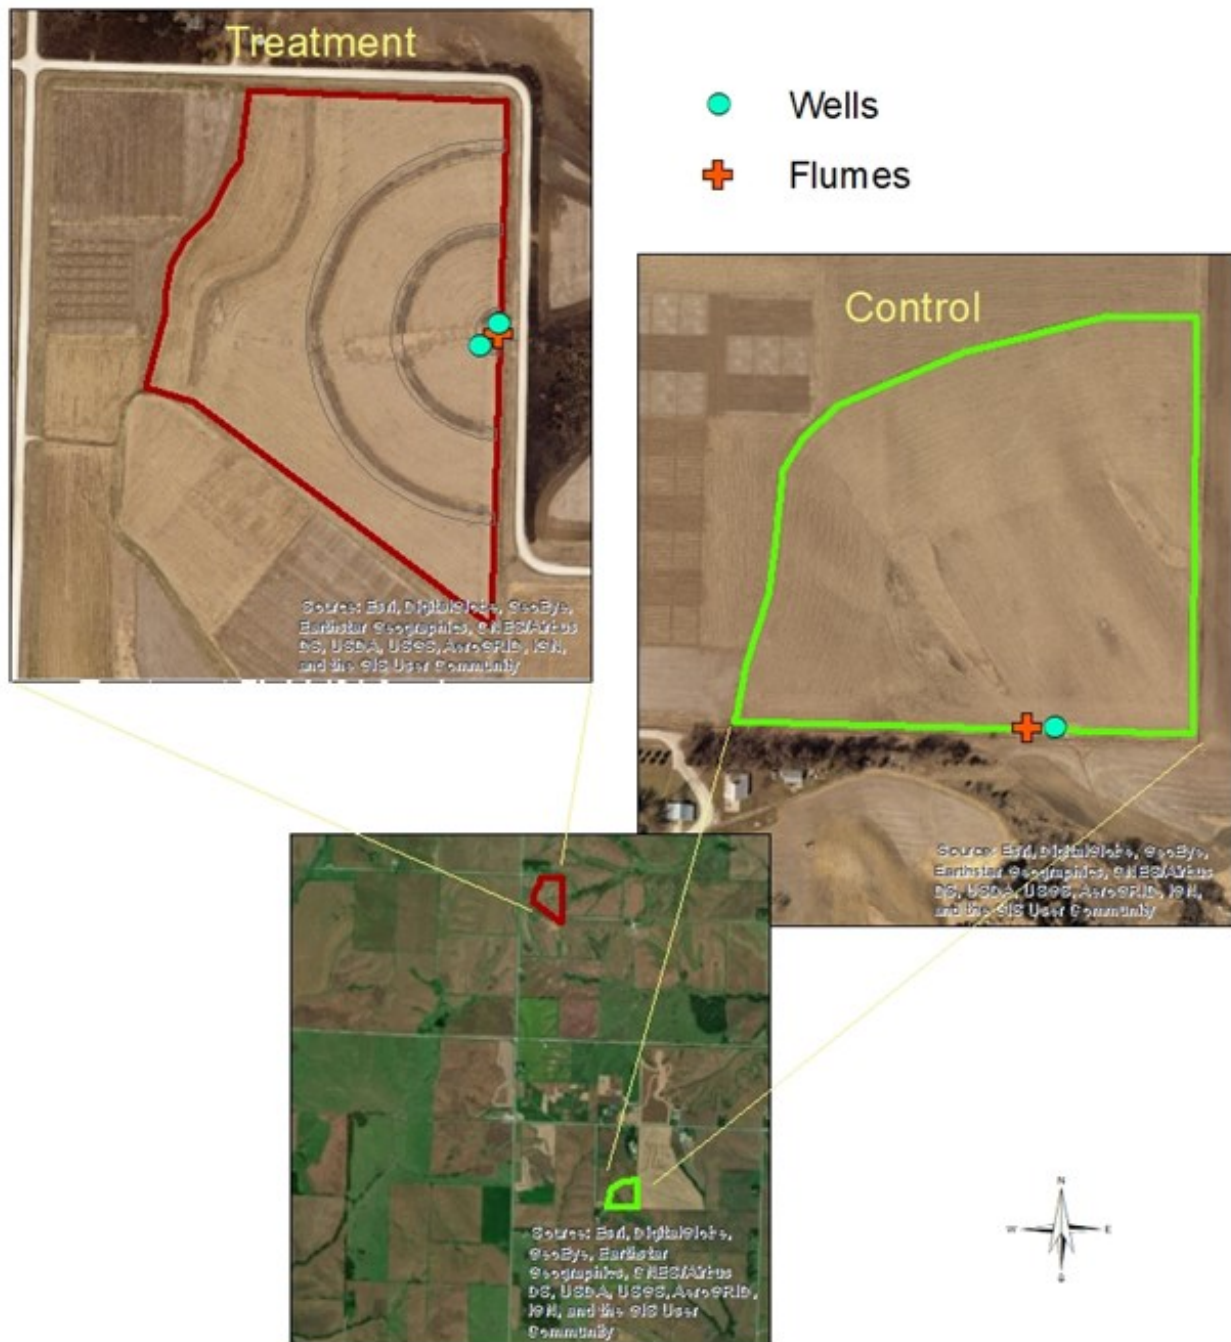
Figure 1. Water quality monitoring locations the ARM site.

The STRIPS team continues to ask how prairie strips affect surface water quantity and quality and how, if at all, prairie strips affect shallow groundwater levels and quality. To answer those questions, we are comparing small drainage areas of farmed fields with prairie strips installed (treatment or “TRT”) to nearby similar fields without prairie strips (control or “CTL”, see Table 1 for areas and slopes). We are calling these paired comparison sites, and are monitoring 7 of them across the state of Iowa. At each of these 7 sites, surface water runoff volume and water quality is being measured by means of automated water samplers and hydrologic flumes located at the spot where runoff is exiting the monitored drainage area (Figure 1).

Shallow groundwater wells were installed at a depth of 15 feet to monitor depth from ground surface and water quality. In the treatment fields, wells were installed at the upper and lower edge of the lowest prairie strip. In the control field, a single well was installed near the hydrologic flume (Figure 1). Groundwater depth measurements and samples are collected on a monthly basis and analyzed for concentrations of Nitrate-N, and orthophosphate.

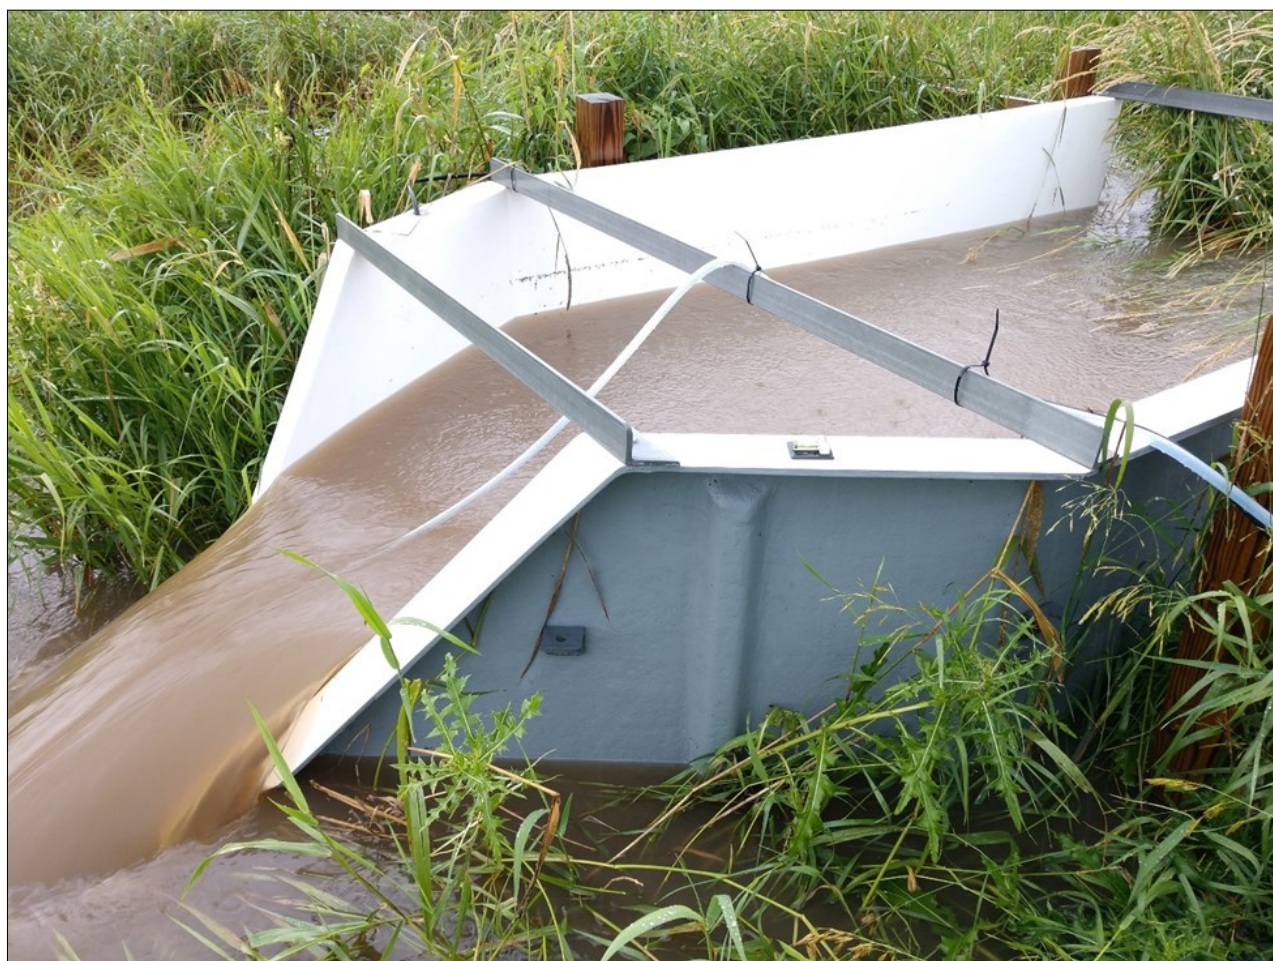
Figure 2: A major runoff event flowing through the treatment H-flume at the EIA site on June 21st, 2018.
