2018 STRIPS Landowner Report

STRIPS 2018 Research Summary

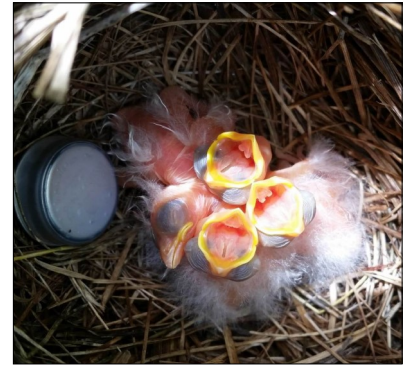
Dickcissel nestlings and iButton for monitoring.

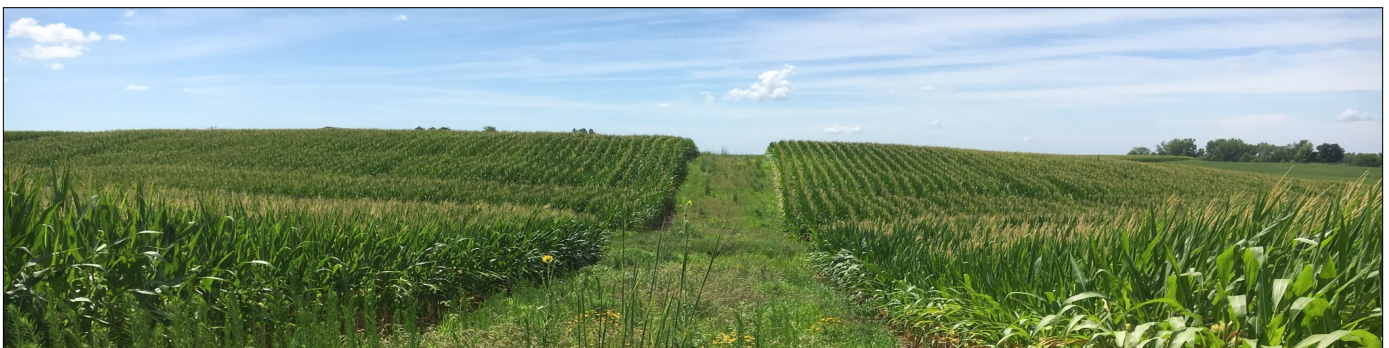
A prairie strip during the establishment phase.

One of the questions the STRIPS team is interested in investigating is the dynamics of the plant communities in prairie strips. For example, how does plant community composition change during the first few years of prairie strip establishment and what is the plant community composition of an established prairie strip? To understand to what extent the plant community changes over time and what factors influence the diversity of plant communities across sites, Farnaz Kordbacheh and Lydia English both conducted research on the plant composition of prairie strips across multiple sites. Farnaz revealed that over time, species composition shifted toward higher rates of prairie plant cover and suppressing weed abundance (Figure 1) and that total plant cover and total species richness increased over time (Figure 2).

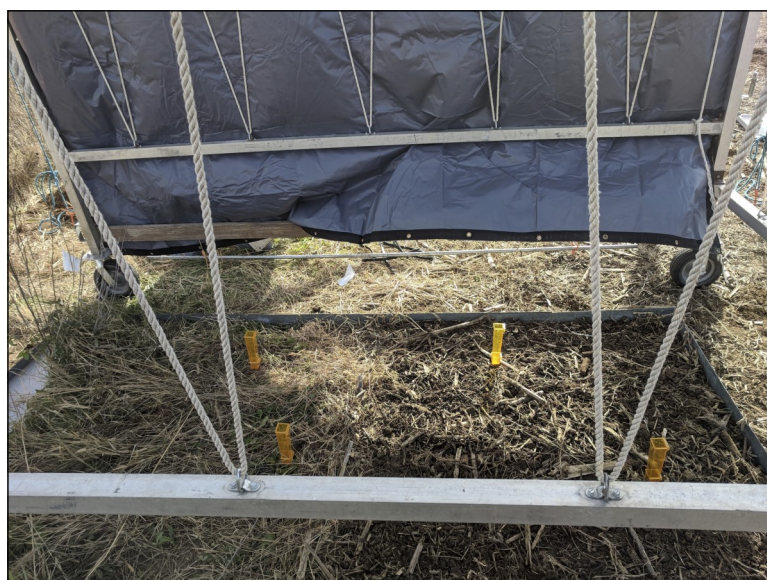
A view of the sampling set up under a rainfall simulation.

During plot runoff, six runoff water samples were taken at 5-minute intervals for microbial processing. Samples were also collected for 1-minute intervals to calculate runoff rate. Samples from the tank containing rainwater and samples of the manure were also taken to measure any organisms that were already present. DNA extraction was carried out on all samples and will be utilized for sequencing and molecular detection of DNA, which will help us identify which organisms are present. Water samples were combined from each of the nine plots and then tested for fecal indicator bacteria, tetracycline, and tylosin-resistant bacteria

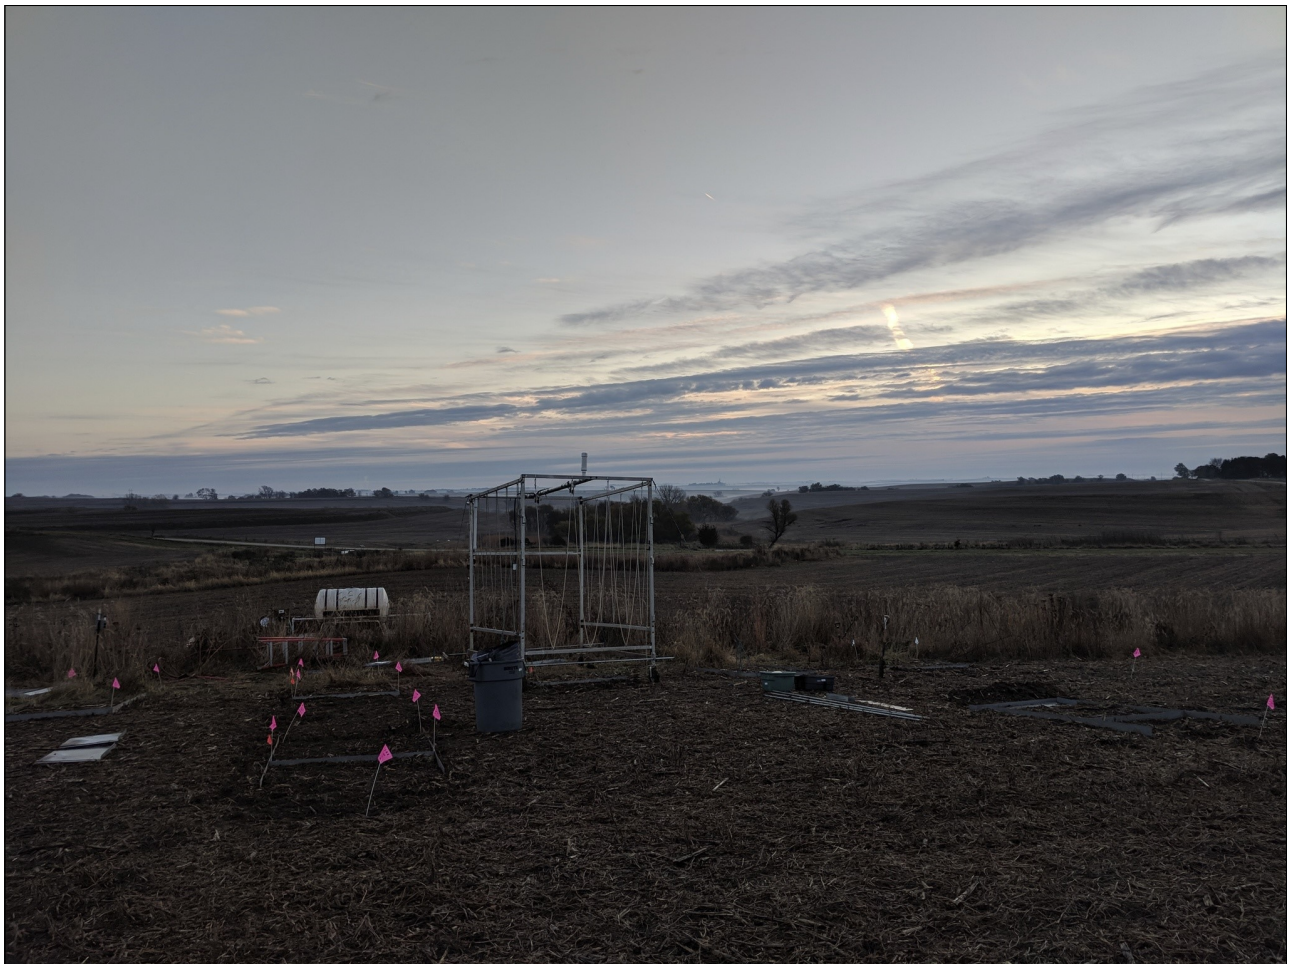
A day ends after setting up the rainfall simulator.

We have not processed many samples yet, but so far we have not observed tetracycline or tylosin-resistant bacteria on plots where manure was not applied but we have seen a decrease in tetracycline and tylosin-resistant bacteria in plots that did not have prairie strips compared to plots that did have prairie strips. Currently, we are anticipating carrying out a similar rainfall simulation in 2019 utilizing cattle manure instead of swine manure. Sequencing results from the 2017 and 2018 rainfall simulations will be available to us sometime in 2019.

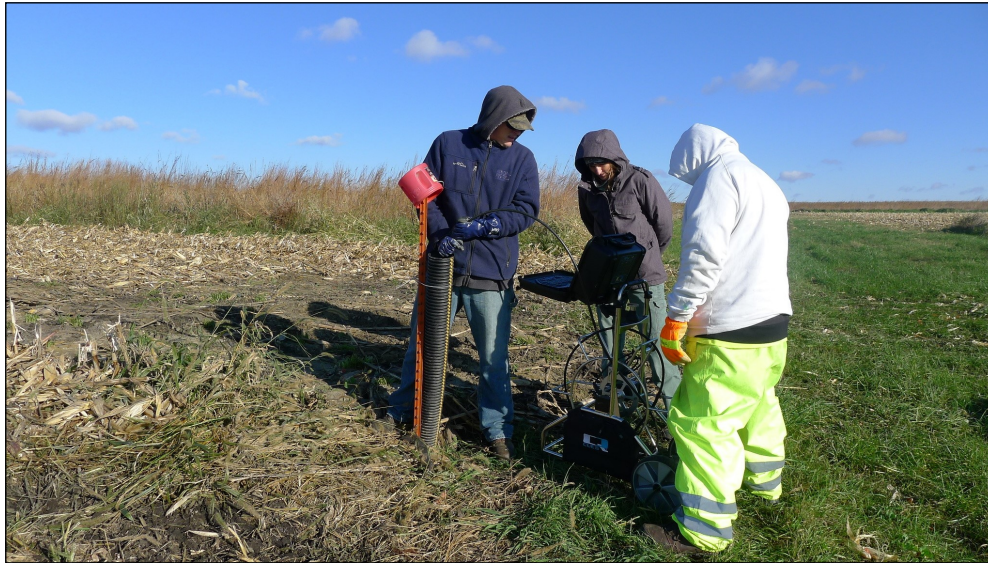
Ashley Kittle, Prairie On-Farms program manager at the Tallgrass Prairie Center, inspects a tile with tiling contractors.

The TPC, as well as the STRIPS team and others, recognize the importance of additional tile-line camera work, to complement and add to information learned from the 2017 STRIPS video. To that end, the TPC partnered with a landowner near Rowley for an early-fall video inspection of a 5" perforated field tile running under a contour prairie strip planted in 2012. There have been no noted issues with this tile line.

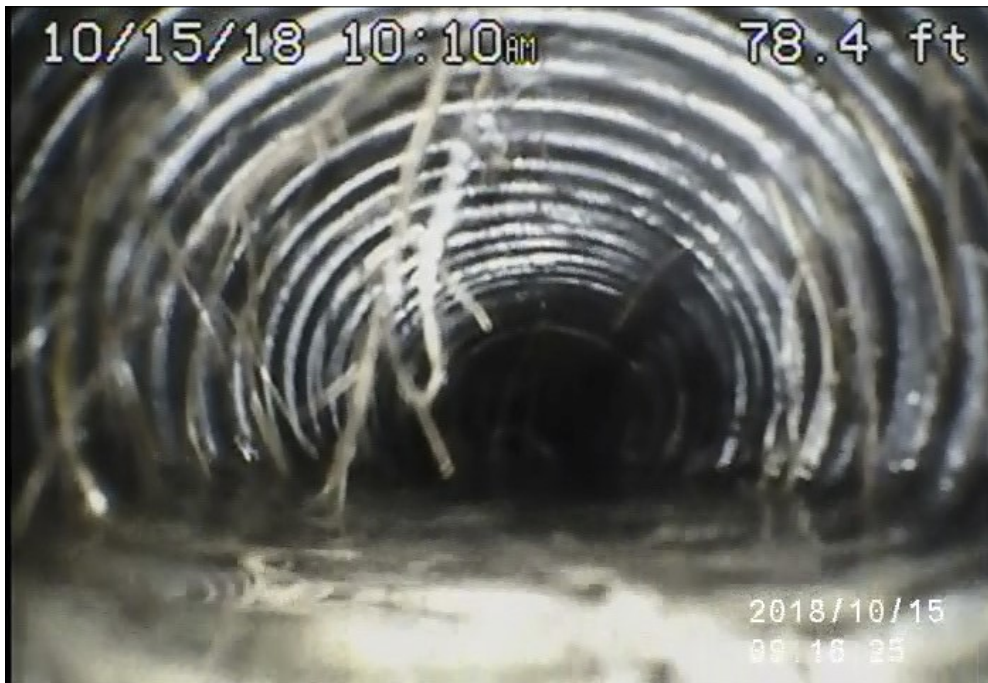
A screenshot of a tile investigation.

The TPC has shared the video with the ISU STRIPS team and other collaborators. Roots were prevalent along the entire 200' of videoed tile. While the roots were more dense in some areas than others, the density under the corn and prairie was similar. Though root biomass was present, the tile was functioning properly; about 1" of water was draining freely.

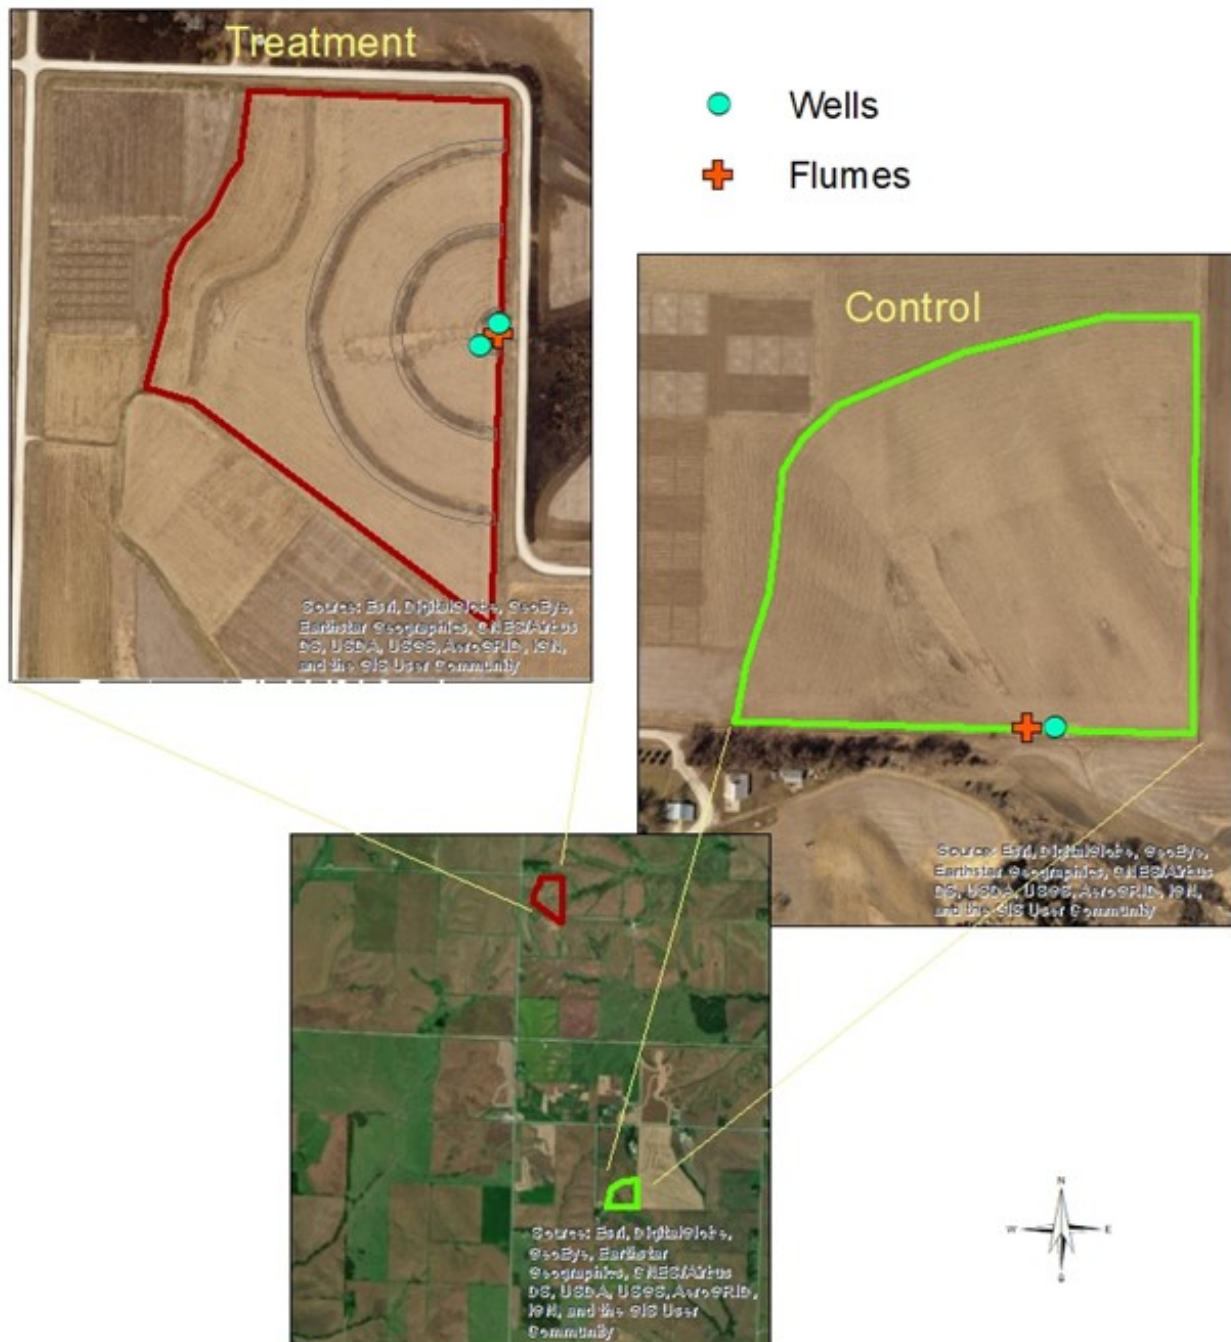
Figure 1. Water quality monitoring locations the ARM site.

The STRIPS team continues to ask how prairie strips affect surface water quantity and quality and how, if at all, prairie strips affect shallow groundwater levels and quality. To answer those questions, we are comparing small drainage areas of farmed fields with prairie strips installed (treatment or “TRT”) to nearby similar fields without prairie strips (control or “CTL”, see Table 1 for areas and slopes). We are calling these paired comparison sites, and are monitoring 7 of them across the state of Iowa. At each of these 7 sites, surface water runoff volume and water quality is being measured by means of automated water samplers and hydrologic flumes located at the spot where runoff is exiting the monitored drainage area (Figure 1).

Shallow groundwater wells were installed at a depth of 15 feet to monitor depth from ground surface and water quality. In the treatment fields, wells were installed at the upper and lower edge of the lowest prairie strip. In the control field, a single well was installed near the hydrologic flume (Figure 1). Groundwater depth measurements and samples are collected on a monthly basis and analyzed for concentrations of Nitrate-N, and orthophosphate.

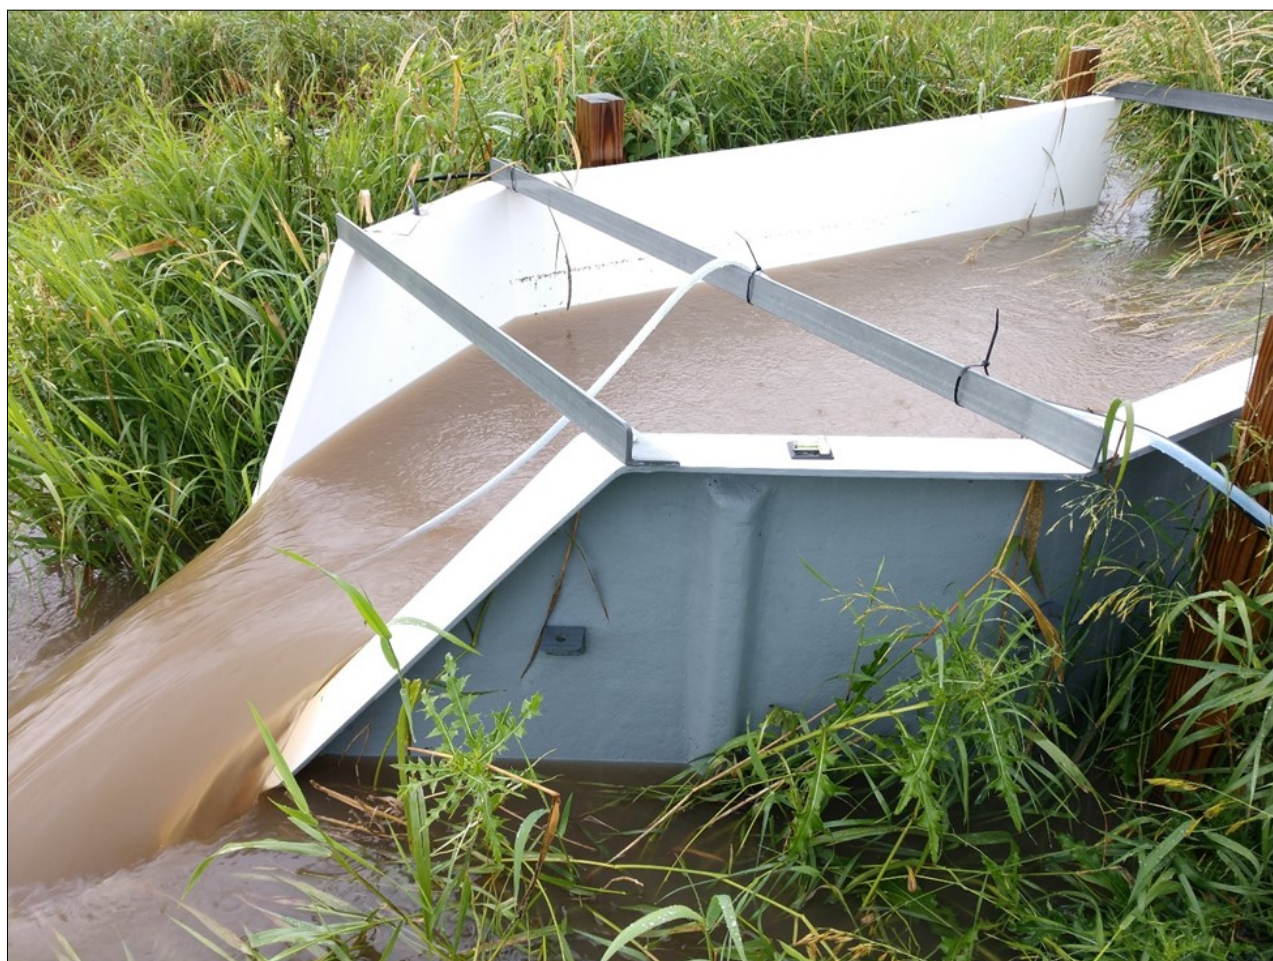
Figure 2: A major runoff event flowing through the treatment H-flume at the EIA site on June 21st, 2018.
